## Estimating the Condition of the Metal Embroidery Threads in Ottoman Textiles in Al-Manyal Palace Museum in Cairo

Omar Abdel-Kareem

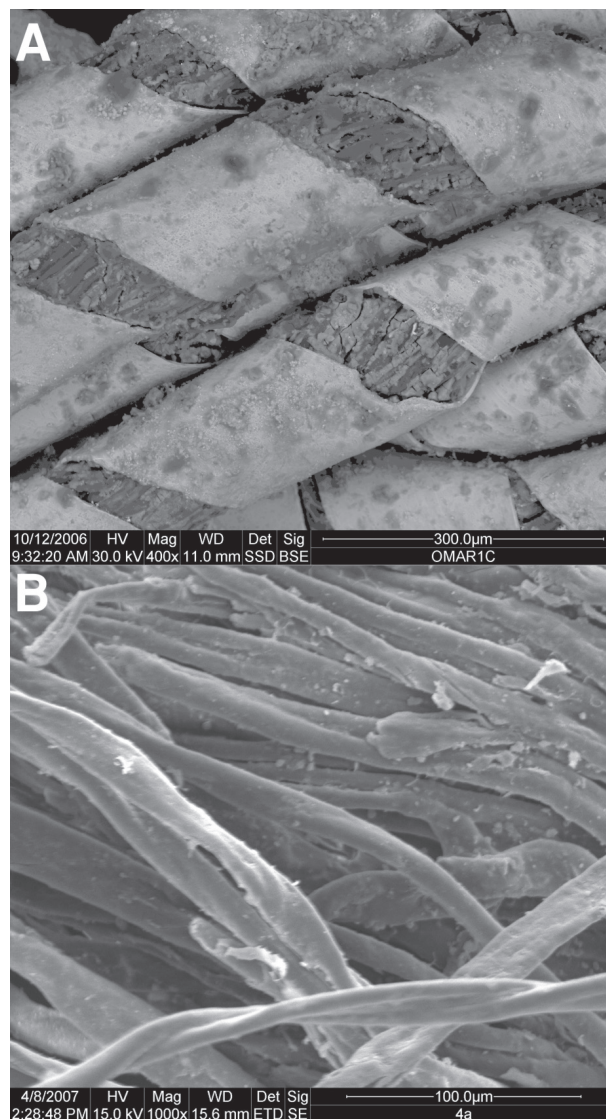
**Fig. 1: SEM Photographs of a metal embroidery thread taken from object 1; A) metal strips; B) cotton fiber core**

**3.1. Morphological Investigation:** The results of the SEM morphological examination of the embroidered metal threads in object 1 show that the metal thread in this object was made of metal strips wound around a fibrous core of cotton fiber yarn (see figure 1). The width of the strip is about 0.2 mm while the thread thickness is about 0.12 to 0.2 mm. The twisting direction of the strip wound around the fiber core is a clockwise, that is a 'Z' twist. The strip has been taken (cut) from a thin metal foil as it is noticed that there are obvious signs in the sample edges of the cutting tool used for making the strip from metal foil. Also the results show that there is a thick corrosion layer on the surface of the metal strips. There are obvious signs of the damage in the metal strip since it is broken and corroded.

The results in figure 7 and table 2 show that the surface concentration of contaminant elements such as O, Al, Si, S, Cl, K, Ca and Fe are very high in the metal threads of object 1. The percentage of contaminants is about 56% while the percentages of copper (Cu) and silver (Ag) are about 42% and 2% respectively.

This result confirms that the sample is covered with a thick layer of corrosion products. The metal threads in this object suffer from high deterioration. The contamination elements probably originated from corrosion products and dirt on the surface of metal threads. These corrosion products and dirt that cover the samples may be a result of the higher pollution in the museum in the presence of higher relative humidity (RH) as an effect of plants and closeness to the river Nile.

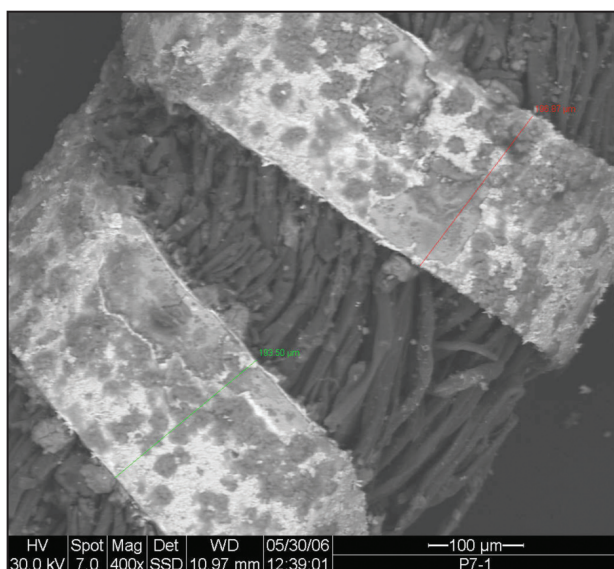
**Fig. 2: SEM Photograph of a metal embroidery thread taken from object 2**

The results of SEM morphological examination of metal threads in object 2 show

that the metal thread in this object was also made of metal strips wound around a fibrous core of cotton fiber yarn. The width of the strip is about 0.14 mm while its thickness is about 0.39 mm. The twisting direction of the strip wound around the fiber core is a clockwise 'Z'. The strip may have been made by cutting from a thin metal foil as there are obvious signs in the edges of the sample (see figure 2 which show the effects of the cutting tool used for making the strip from metal foil). The examinations show that the strips had been attacked and deteriorated. There is a thick layer of corrosion products covering the whole surface of the metal strips. There are obvious signs of the damages in the metal strip since it is broken and corroded, and there are a lot of corrosion pits.

The results in table 3 show that the surface concentration of contaminant elements such as C, O, Al, Si, S, Cl, K, Ca and Fe are high in metal threads in object 2. The percentages of copper (Cu) and silver (Ag) are about 37% and 2% respectively while the percentages of contamination elements are about 61%. This result confirms that the sample is covered with a thick layer of corrosion products. This confirms that the metal threads in this object also suffer from high deterioration. The contamination elements are probably derived from corrosion products and dirt on the surface of metal threads. These corrosion products and dirt that cover the samples may be a result of the causes mentioned above.

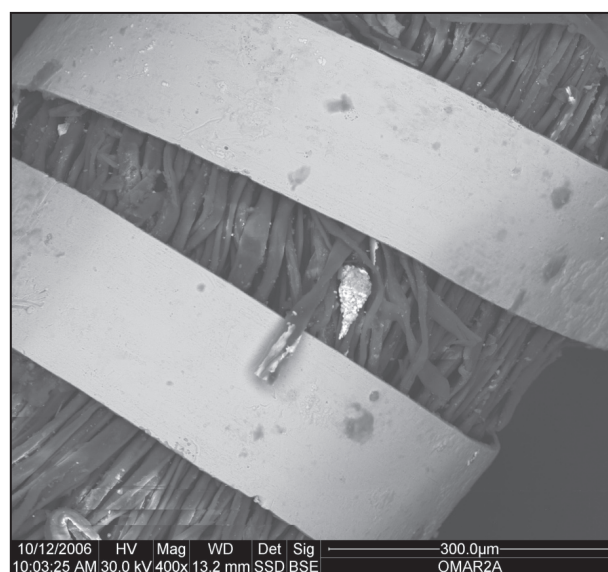
The results of SEM morphological examination of metal threads in object 3 show that the metal threads were made of metal strips wound around a fibrous core of cotton fiber yarn. The width of the strip is about 0.17 mm while the fiber thickness is about 0.47 mm. The twisting direction of the strip wound around the fiber core is a clockwise 'Z'. The strip may have been made by cutting from a thin metal

**Fig. 3: SEM Photograph of a metal embroidery thread taken from object 3**

foil as there are obvious signs in the sample edges (see figure 3 which shows the effects of the cutting tool used for making the strip from metal foil). Also the examinations show that the strips had been attacked and deteriorated. There is a thin layer of corrosion products covering the whole surface of the metal strip. Also it is obvious that there some areas of the surface are covered with a thick layer of corrosion crusts. In general this sample presents the least damage in the surface compared to all tested samples.

The results in table 4 show that the initial intensities of contamination elements such as O, Si, S, Cl, K, Ca and Fe are not high in metal threads in object 3. The percentages of copper (Cu), silver (Ag) and gold Au are about 82 %, 2% and 2.5% respectively, while the percentage of contamination elements is about 23%. This result confirms that the sample is covered with a thin layer of corrosion products compared with samples 1 and 2. This shows that the metal threads in this object suffer from deterioration too but less than that of the metal threads in objects 1 and 2. This is because this object is displayed in a closed showcase that reduces the effect of both RH and the pollution in the environment surrounding the objects. The obtained contamination elements are probably derived from corrosion products and dirt on the surface of the metal threads.

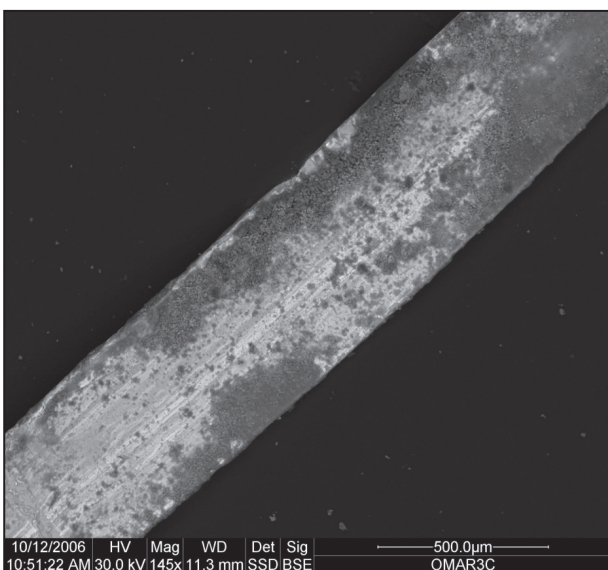
The results of SEM morphological examination of metal threads in object 4 show that the metal thread was made of solid metal strips without fiber core. The width of the strip is about 0.29 mm while the thread thickness is about 1.08 mm. Also the strip may have been made by cutting from a thin metal foil as there are obvious signs in the sample edges (figure 4 shows the effects of the cutting tool used for making the strip from metal foil). Also the results show that the strips had been attacked and deteriorated. A thick layer of corrosion products covers the whole surface of the metal strips. There are obvious signs of the damage in the metal stripe as it is broken and corroded and

**Fig. 4: SEM Photograph of a metal embroidery thread taken from object 4**

there are a lot of corrosion pits.

The results in table 5 show that the surface concentration of contaminant elements such as O, Si, S, Cl, K, Ca and Fe in the metal threads of object 4, are higher than object 3 but less than in objects 1 and 2. The percentages of Cu, Au and Zn are about 60 %, 15%, 5% respectively, while the percentage of contaminant elements is about 20%. This result confirms that this object is covered with a thin layer of corrosion products compared with objects 1 and 2. The metal threads in this object suffer from deterioration but less than the deterioration in samples 1 and 2. This is because this object is displayed in a closed showcase that reduces the effect of both RH and pollution in the environment around the objects.

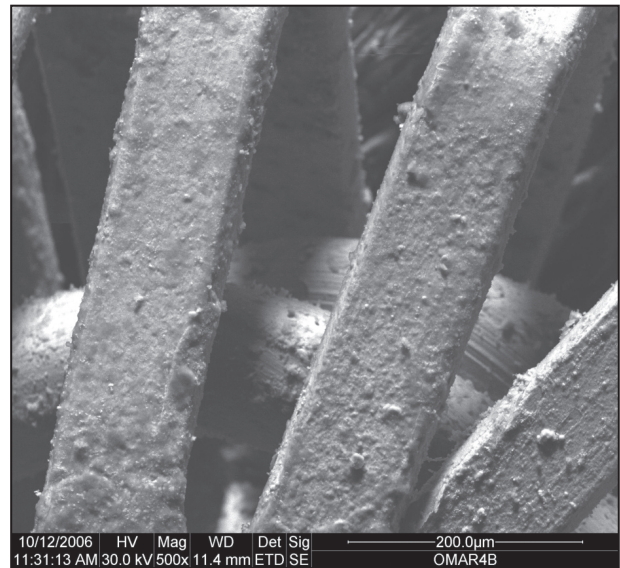
**Fig. 5: SEM Photograph of a metal embroidery thread taken from object 5**

The results of SEM morphological examination of metal threads in object 5, show that the embroidered metals in this object are coils made from wires wound around other wires and fibrous core. The wires are rectangular in section (see figure 5). The width of the wire is about 0.1 mm while the coil width is about 0.71 mm. The wires may have been made by hammering rods, as it is noticed that edges of the wires are rounded but the length and width of the wires are rectangular. Also there are signs of the hammering on the surface of the wires. The examinations show that the wires had been attacked and deteriorated. There is a thick layer of corrosion products covering the whole surface of the metal wires. There are obvious signs of the damages in the metal wires as it is broken and corroded and there are a lot of corrosion pits.

The results in table 6 show that the initial intensities of contamination elements such as O, Cl, K and Ca are not high. The percentages of Cu, Au and Ag are about 57%, 15%, and 8% respectively, while the percentage of contaminations is about 20%. This result confirms that object 5 is covered with a thin layer of corrosion products compared with other tested samples. This is because this object is displayed in a closed showcase that reduces the effect of both RH and pollution in the environment surrounding the objects.

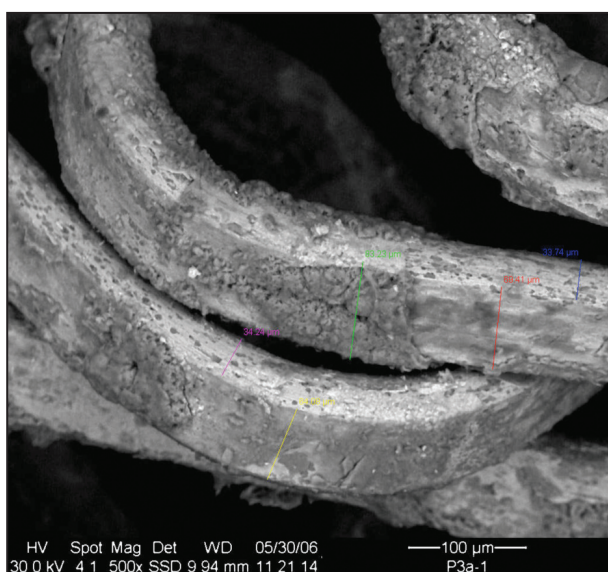
The results of SEM morphological examination of metal threads in object 6 show that the embroidered metals in this object are coils made from wounded wires without a fibrous core. The wires are of a rectangular shape (see figure 6). The thickness of the wire

is about 0.08 mm. The wires may have been made by hammering rods, as it is noticed that edge of the wires are rounded but the length and width of the wires are rectangular. Also there are signs of the hammering on the surface of the wires. The results show that the wires had been attacked and deteriorated. There is a thick layer of corrosion products covering the whole surface of the metal wires. There are obvious signs of damage in the metal wires as it is broken and corroded and there are a lot of corrosion pits. This sample is more degraded and corroded than the previous sample.

**Fig. 6:** SEM Photograph of a metal embroidery thread taken from object 6

of Cu, Zn and Au are about 62.5%, 3%, 2% respectively. This result shows that the sample is covered with a thick layer of corrosion products. This confirms that the metal threads in object 6 suffer from extensive deterioration. The obtained contamination elements are probably derived from corrosion products and dirt on the surface of the metal threads. These corrosion products and dirt that cover the samples may be the result of higher pollution in the museum in the presence of the higher relative humidity (RH) from the effect of plants and closeness to the river Nile.

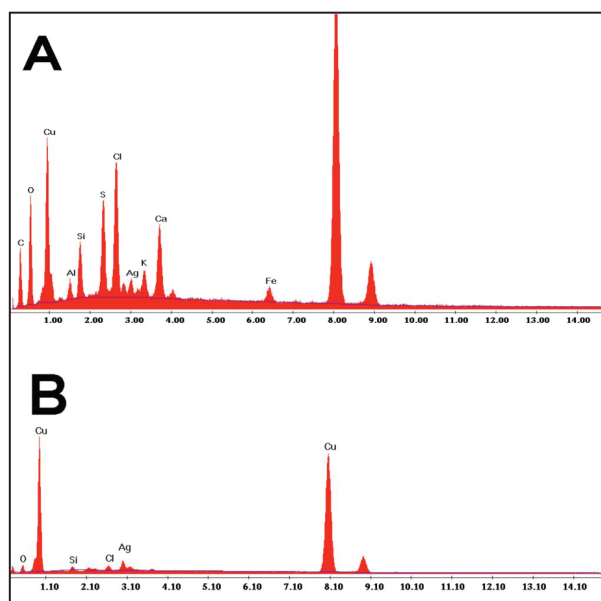
**Fig. 7:** EDX analysis of the chemical composition of sample 1 A) the sample surface; B) the cross section

accounting for about 90% in most of the tested samples. By comparing the obtained results in figure 7 and tables 2-7 it is clear that the corrosion products are too high on the surface of all tested samples.
