## Degradation of Limestone Buildings in Jordan: Working Effects and Conservation Problems "A Critical Study According to International Codes of Practice"

Mohammad A. El-Gohary

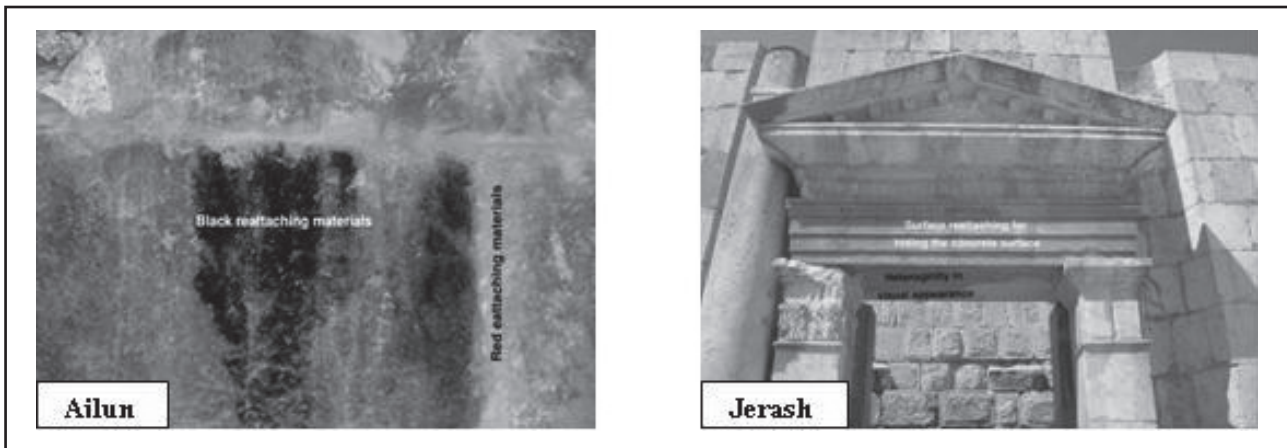
Fig. 2a, b: Shows deterioration appearances resulting from the effects of Surface Retouching

unsuitable organic pigments are used as retouching during the restoration work for hiding the original features of restoration material "mortar and surface plaster" to give them the same visual appearances and external features; these materials such as botanical smut lead to create some acidic pits and facilitate chemical reaction and later surface erosion as is shown in fig. 2a, b.

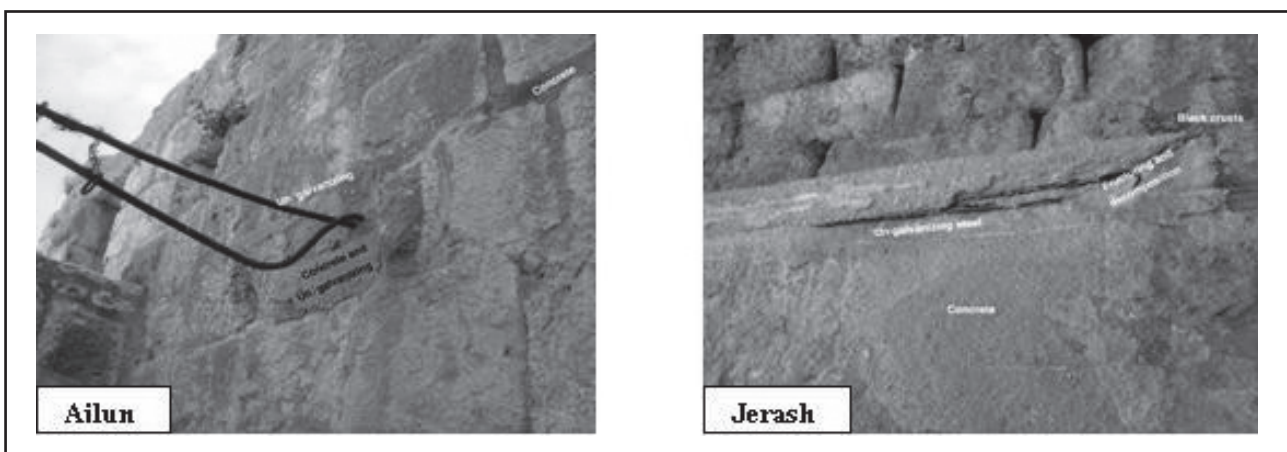
Fig. 3 a, b: Shows deterioration appearances resulting from the effects of using Reinforced Concrete

but this may be suitable in dry areas. On the other hand, most concrete deterioration forms can be attributed to water penetration where concrete absorbs moisture until it becomes saturated and prevents water from gathering on surfaces (Mailvaganam and Litvan, 1997). From this point of view, it could be seen that moisture not only fosters the deterioration mechanisms and promotes chemical reactions, but also carries dissolved chemicals that can have further reaction with the steel, lime and other components in the concrete. It also plays a major role in concrete deterioration through freeze/thaw cycling. In addition, corrosion of steel reinforcement eventually leads to spalling of concrete and propagation of original surface damages as shown in fig. 3 a, b.

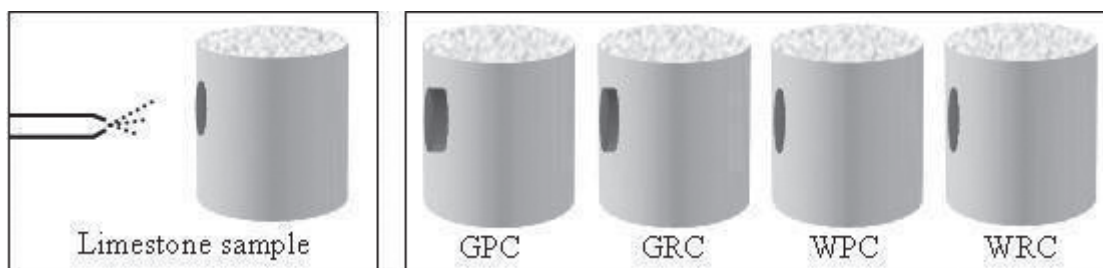
**Fig. 7: Shows micro-abrasion resistance of the materials used in conservation works in Ajlun Castle and Jerash City**

- Time of exposure is 105 seconds, Abrasive powder is sand particles no 500 micron
- Nozzle diameter is 1.07 mm

- Distance between sample and nozzle is 100mm
- Pressure is 2 bar, all results listed in table 3 and Fig. 7
